**Residual Strength and Repair of Damaged and Deteriorated  
Offshore Structures**

**REPAIR OF DENTED TUBULAR COLUMNS -  
WHOLE COLUMN APPROACH**

By  
J.M. Ricles  
W.M. Bruin  
T.K. Sooi

ATLSS Report No. 97-13

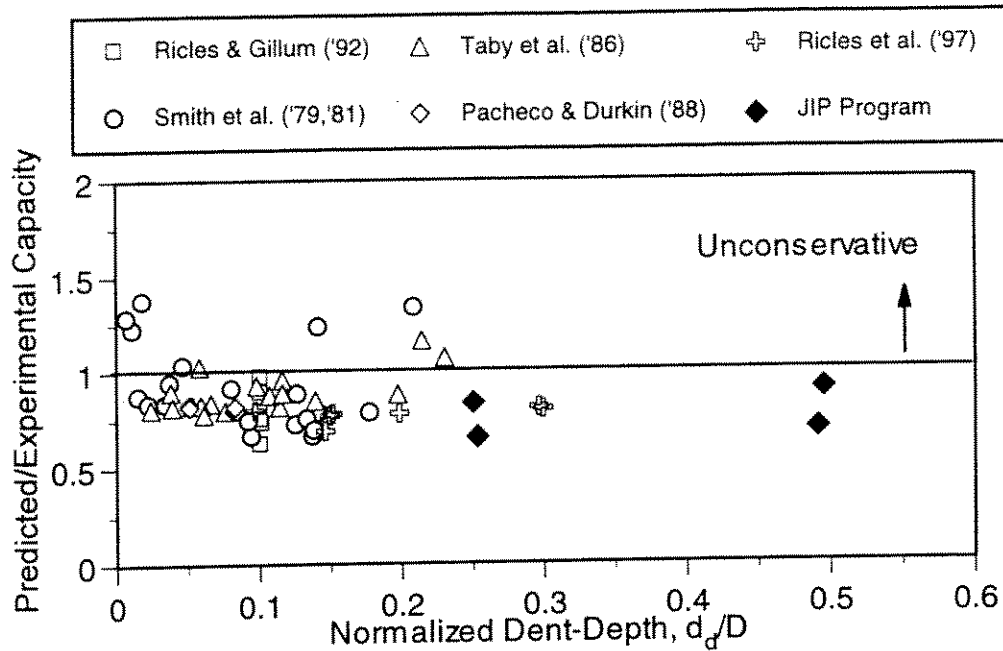
Figure 4.20 - Sensitivity of Ellinas Strength Equation to Depth of Applied Dent-Damage for Specimens with Simply-Supported Boundary Conditions

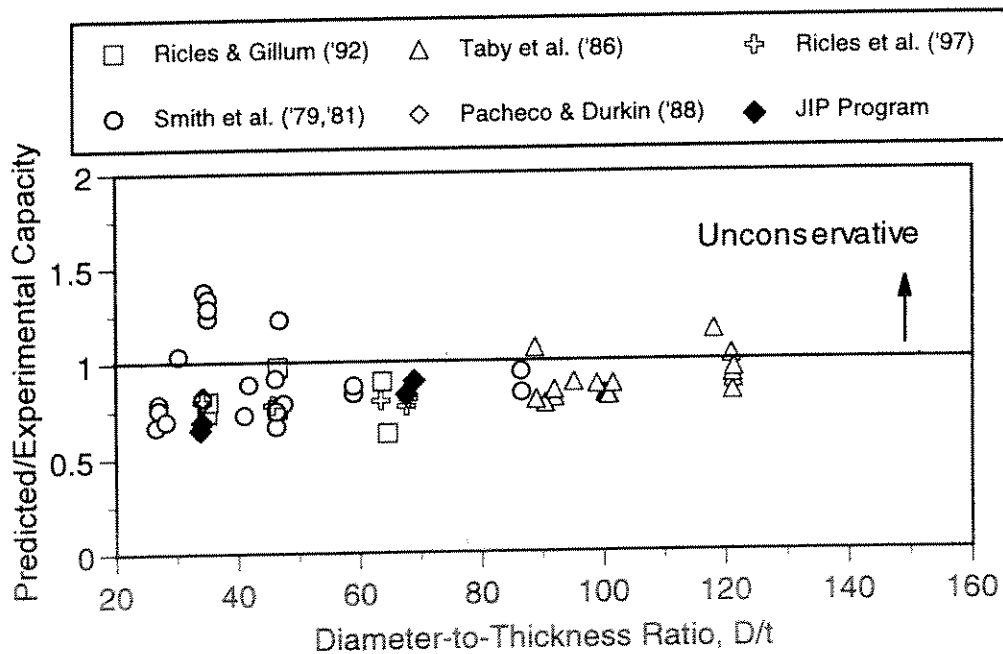
Figure 4.21 - Sensitivity of Ellinas Strength Equation to Diameter-to-Thickness Ratio for Specimens with Simply-Supported Boundary Conditions

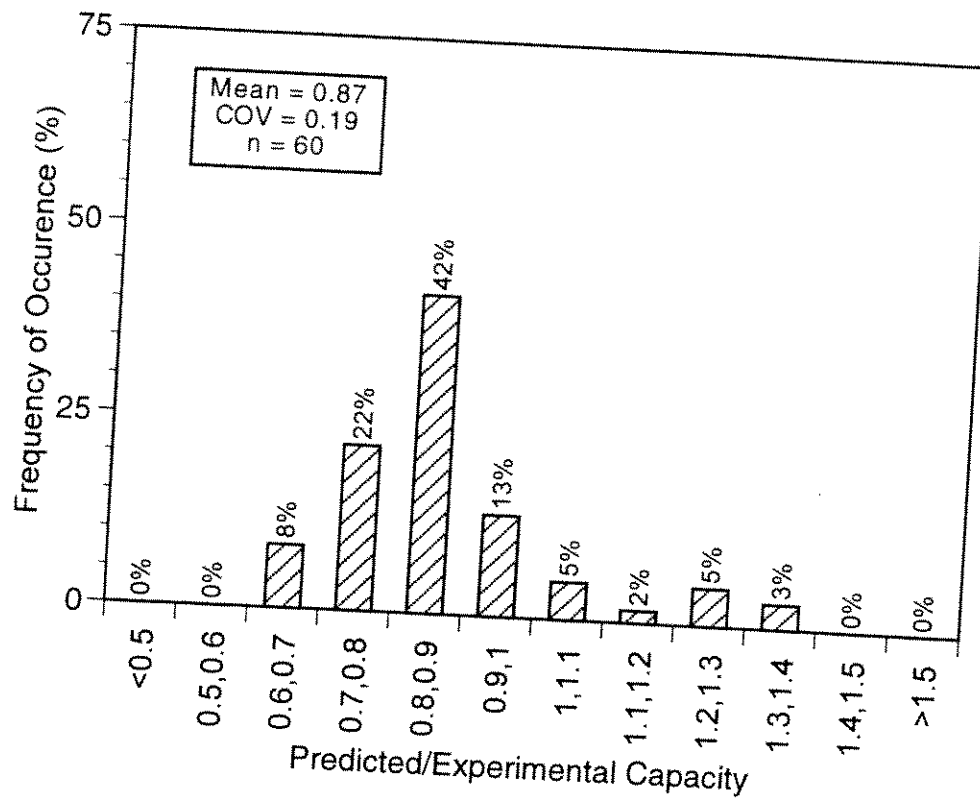
Figure 4.22 - Histogram of Predicted-to-Measured Capacity Ratio for the Ellinas Strength Equation (Includes Current and Previous Experimental Data)

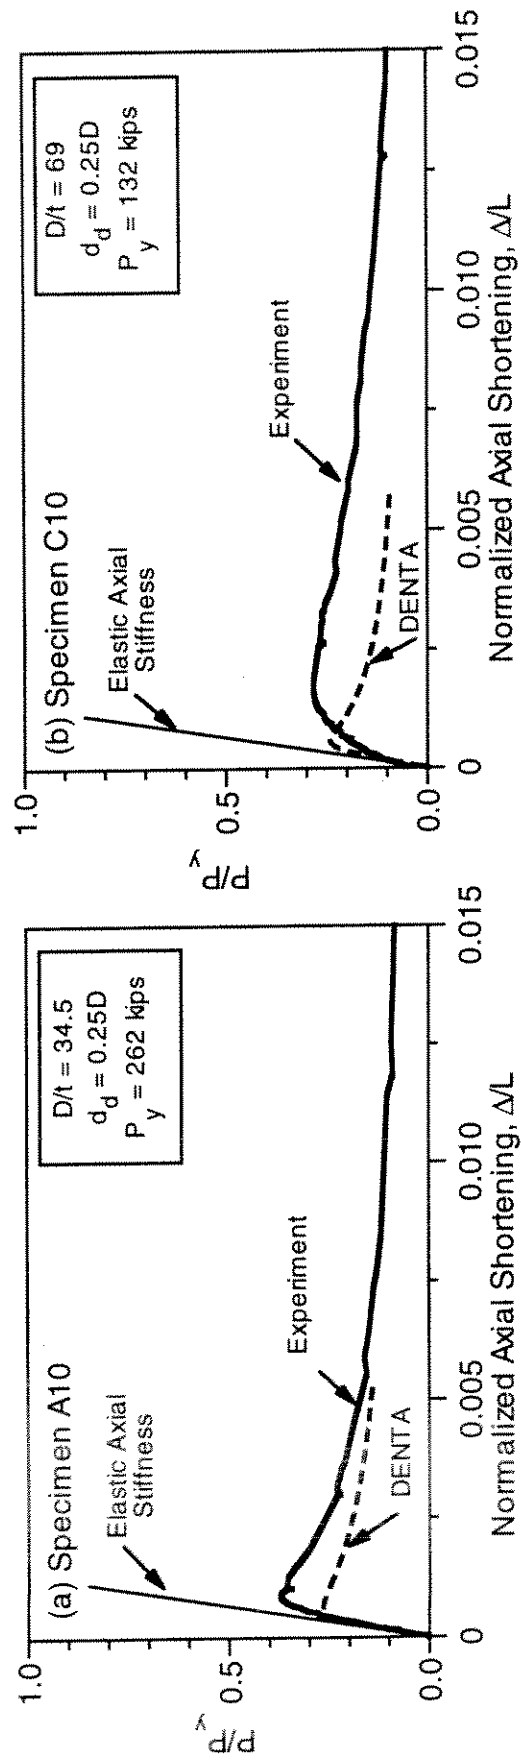
Figure 4.23 - Comparison of DENTA II and Experimental Results for the Axial Load-Shortening Response of Non-repaired Specimens

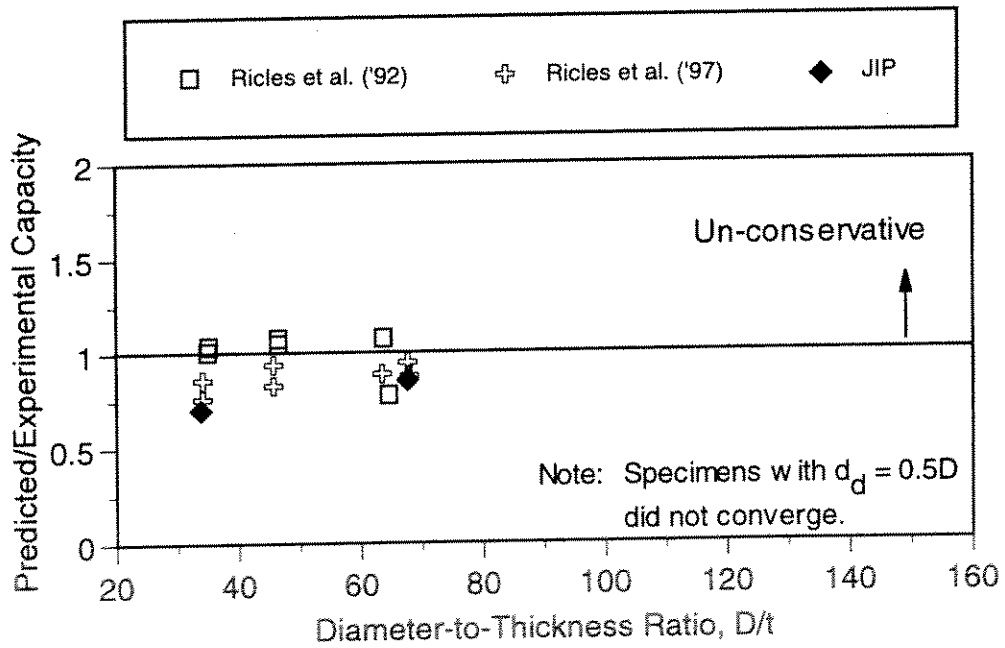
Figure 4.26 - Sensitivity of DENTA II to Diameter-to-Thickness Ratio for Specimens with Simply-Supported Boundary Conditions

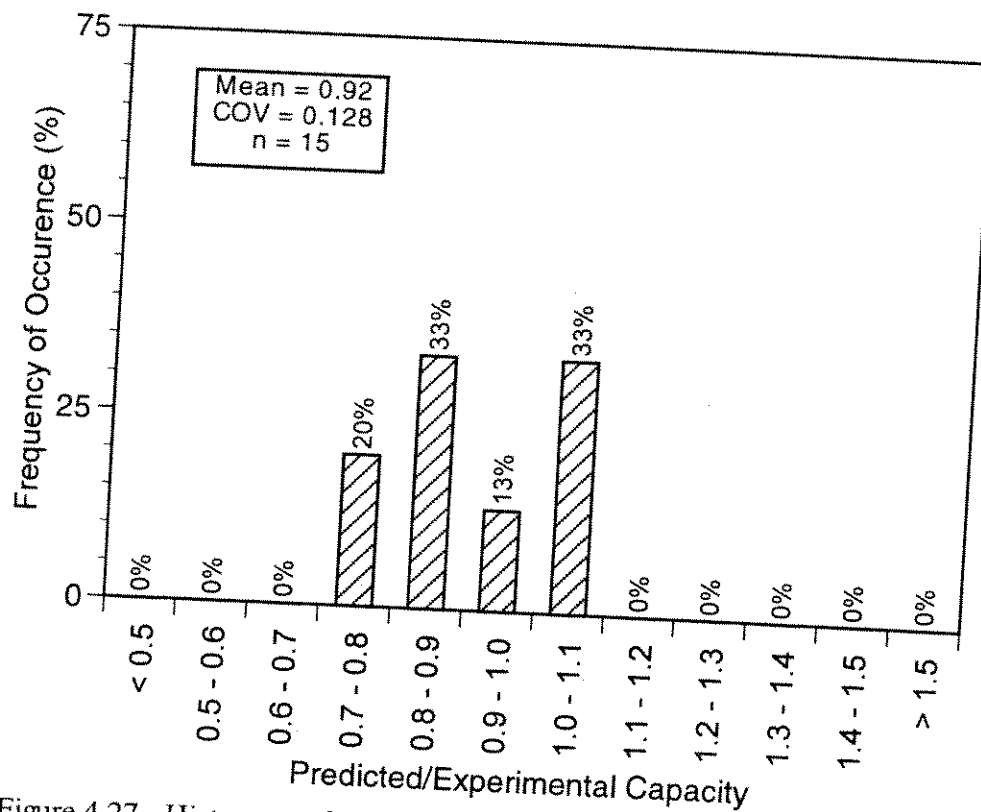
Figure 4.27 - Histogram of Predicted-to-Measured Capacity Ratio for DENTA II  
(Includes Data from Current Program and Ricles et al. [1992, 1997])

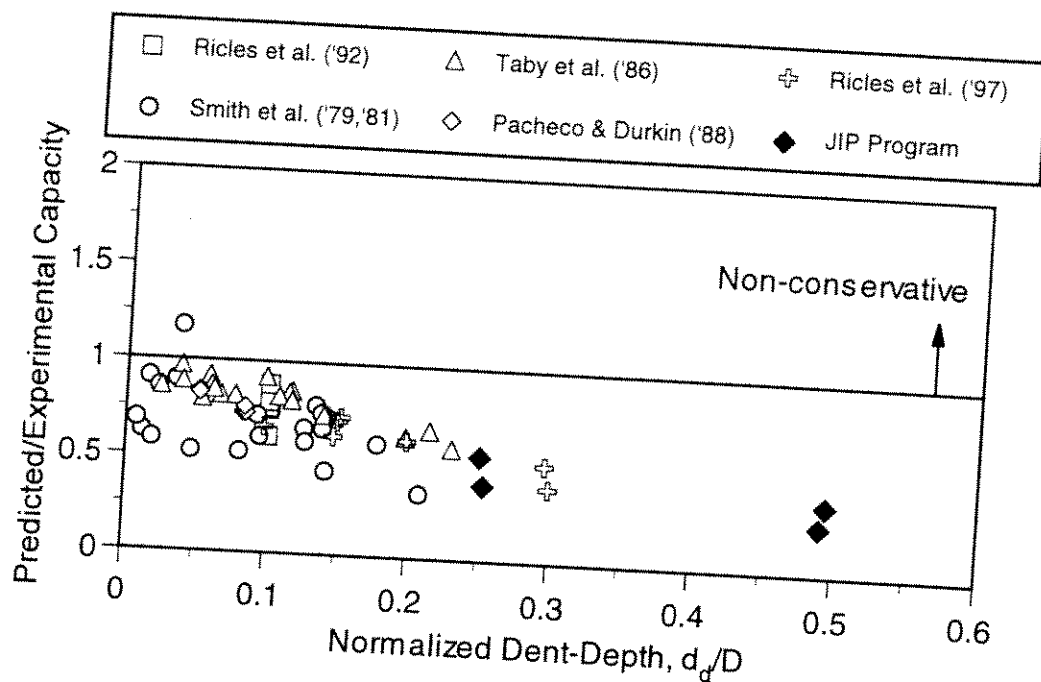
Figure 4.29 - Sensitivity of UCDENT to Depth of Applied Dent-Damage for Specimens with Simply-Supported Boundary Conditions

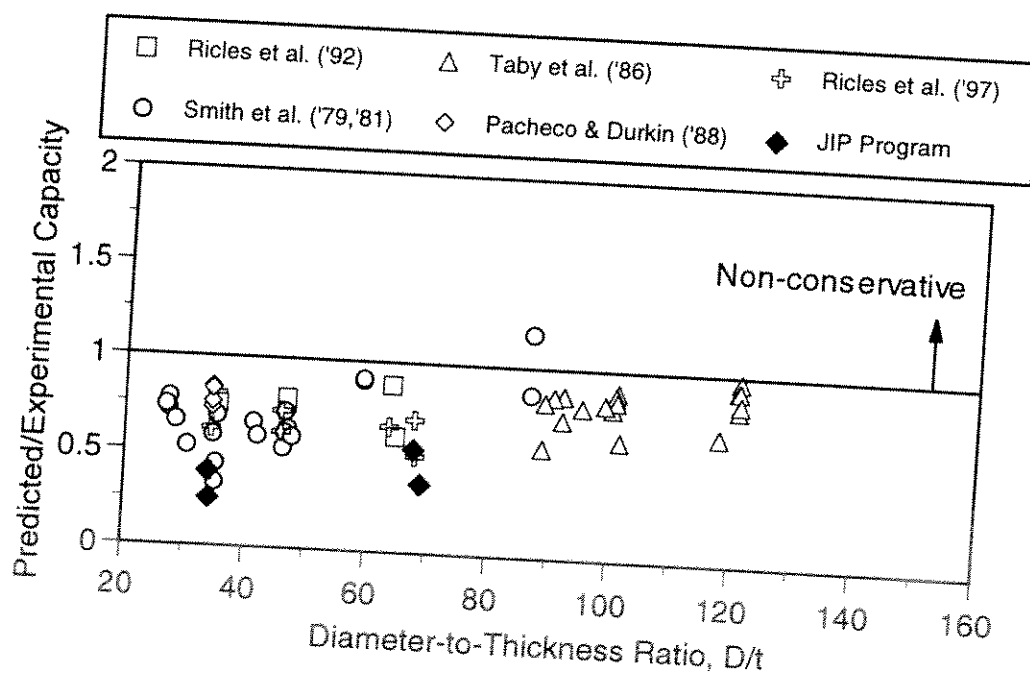
Figure 4.30 - Sensitivity of UCDENT to Diameter-to-Thickness Ratio for Specimens with Simply-Supported Boundary Conditions

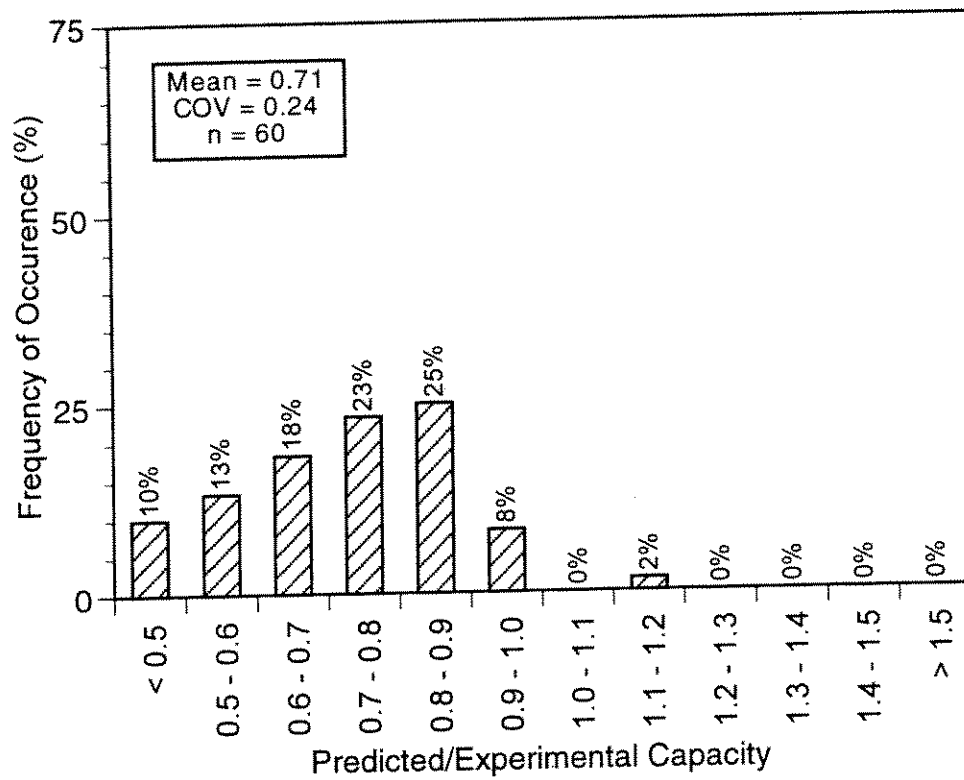
Figure 4.31 - Histogram of Predicted-to-Measured Capacity Ratio for UCDENT (Includes Current and Previous Experimental Data)

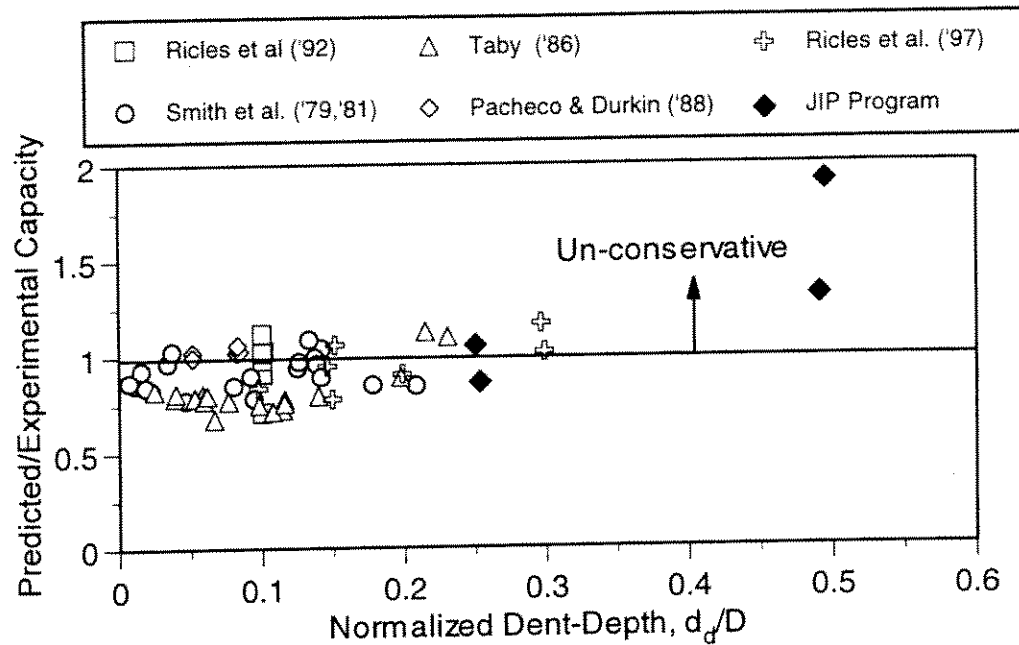
Figure 4.33 - Sensitivity of Loh Unity Check (Stability) Equation to Depth of Applied Dent-Damage for Specimens with Simply-Supported Boundary Conditions

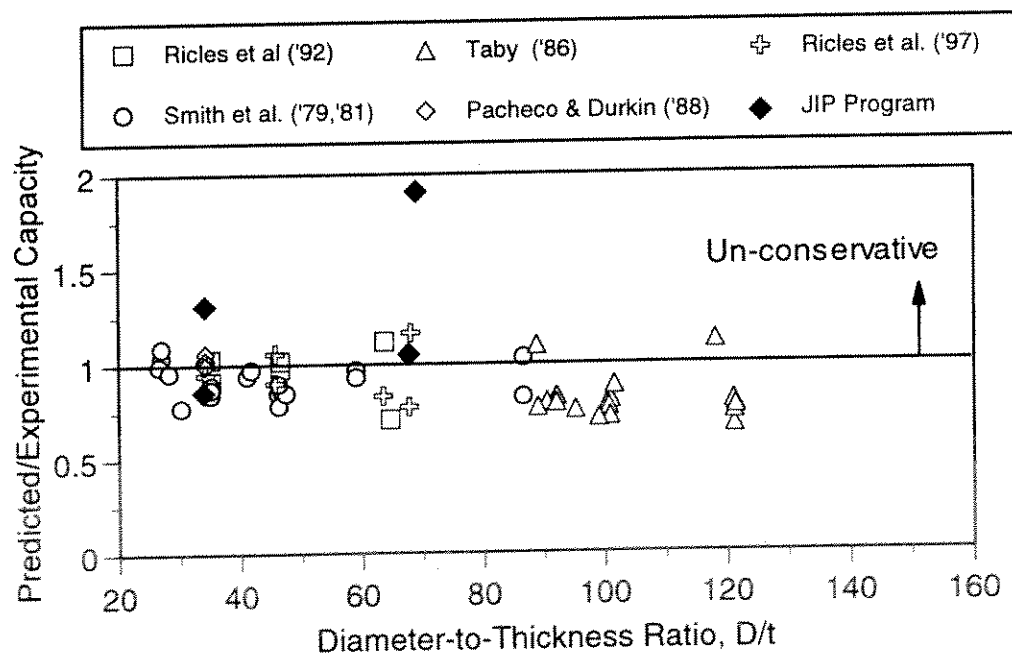
Figure 4.34 - Sensitivity of Loh Unity Check (Stability) Equation to Diameter-to-Thickness Ratio for Specimens with Simply-Supported Boundary Conditions

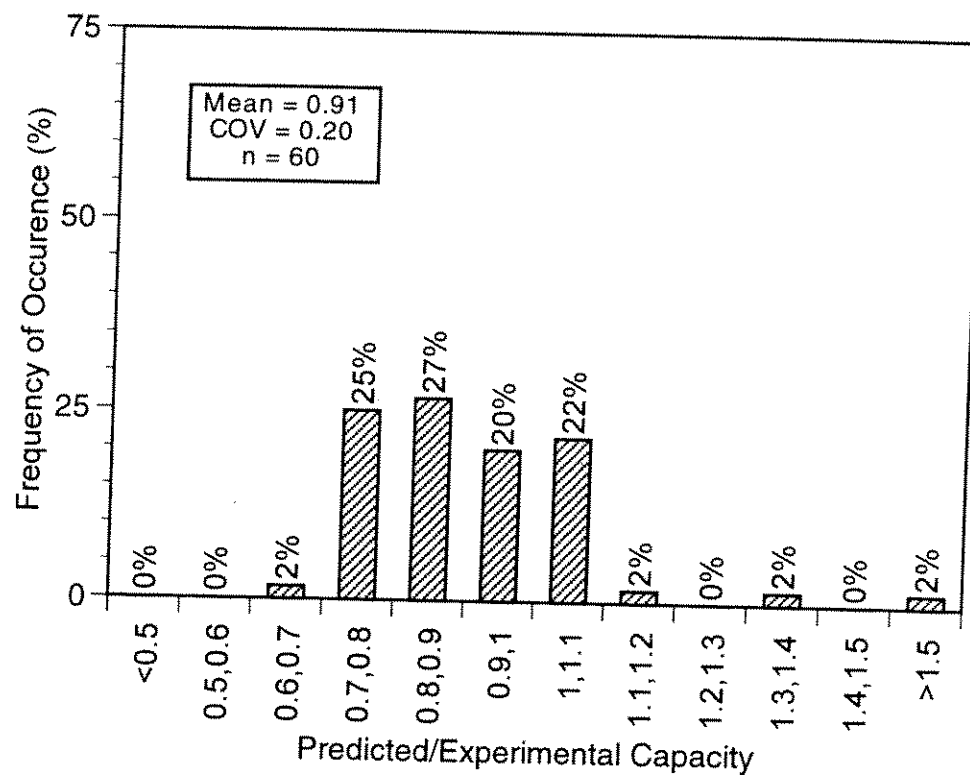
Figure 4.35 - Histogram of Predicted-to-Measured Capacity Ratio for Loh Unity Check Equation (Includes Current and Previous Experimental Data)

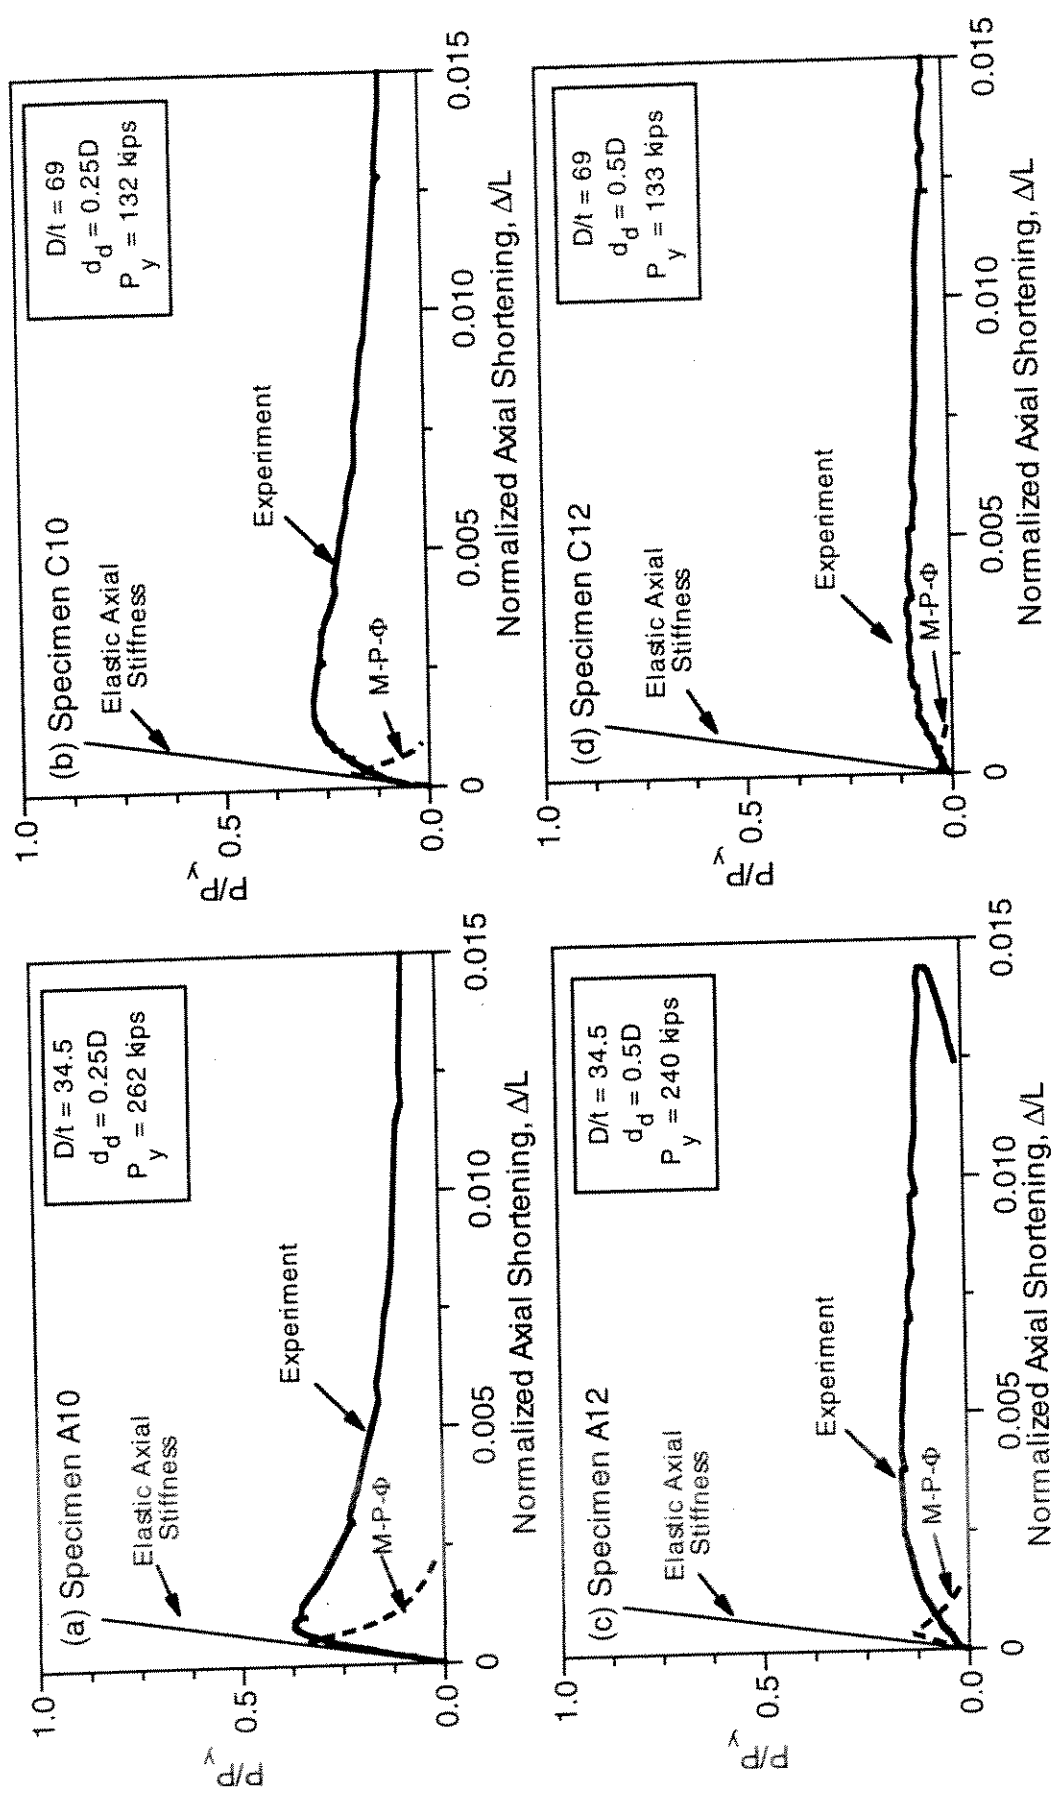
Figure 4.36 - Comparison of M-P- $\Phi$  Based Method and Experimental Results for the Axial Load-Shortening Response of Non-repaired Specimens

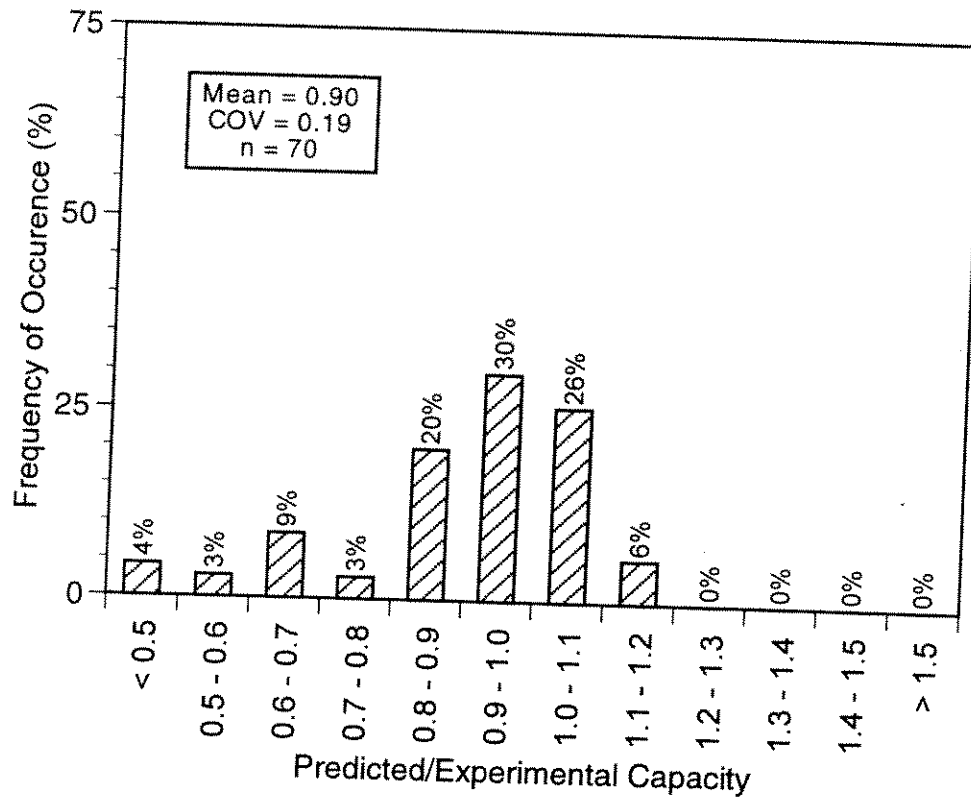
Figure 4.40 - Histogram of Predicted-to-Measured Capacity Ratio for M-P- $\Phi$  Based Method (Includes Current and Previous Experimental Data)

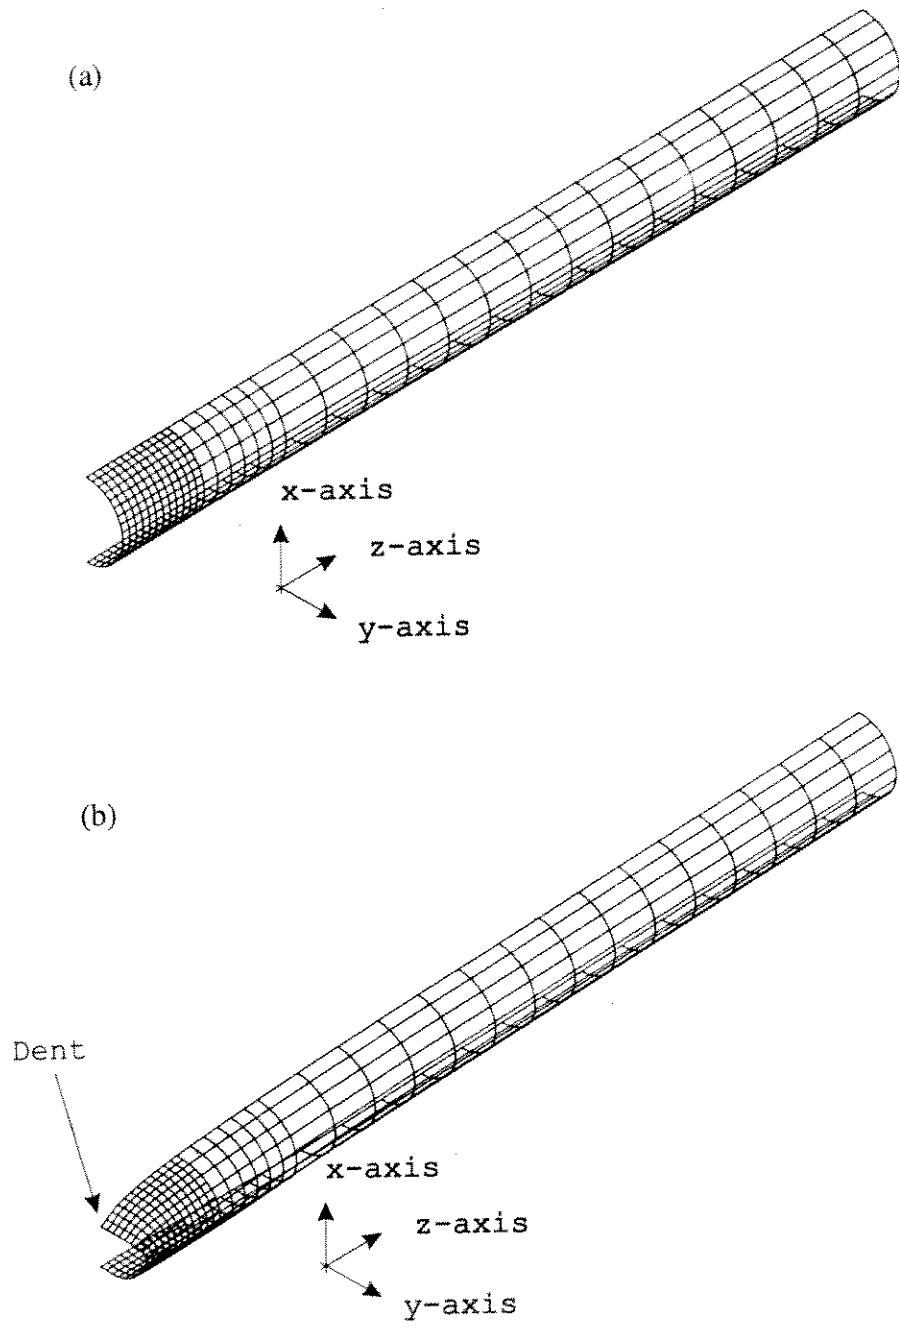
Figure 4.41 - Typical Finite Element Mesh for Non-repaired Specimens, (a) Undeformed Prior to Denting, and (b) Deformed Model Following Denting (after Ricles et al. 1997)

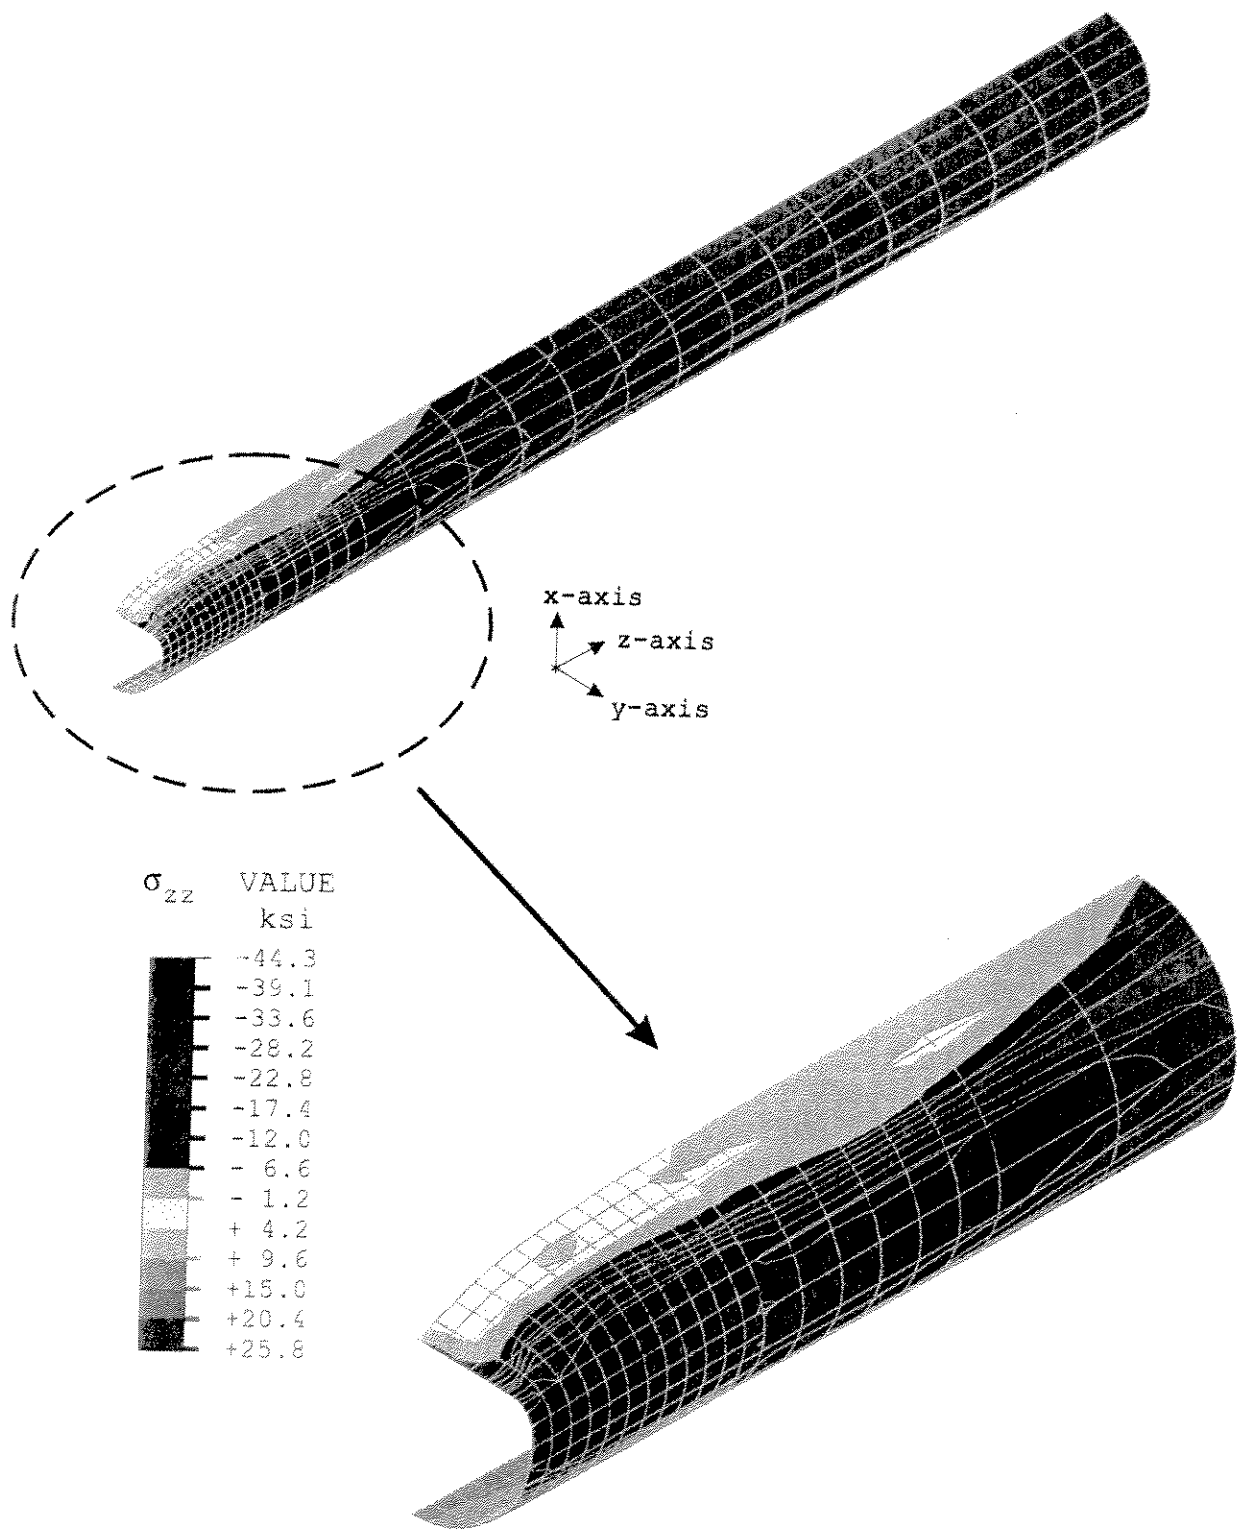
Figure 4.42 Longitudinal Stress Contour of Steel Tube of Specimen A10 at Maximum Axial Load in Analysis

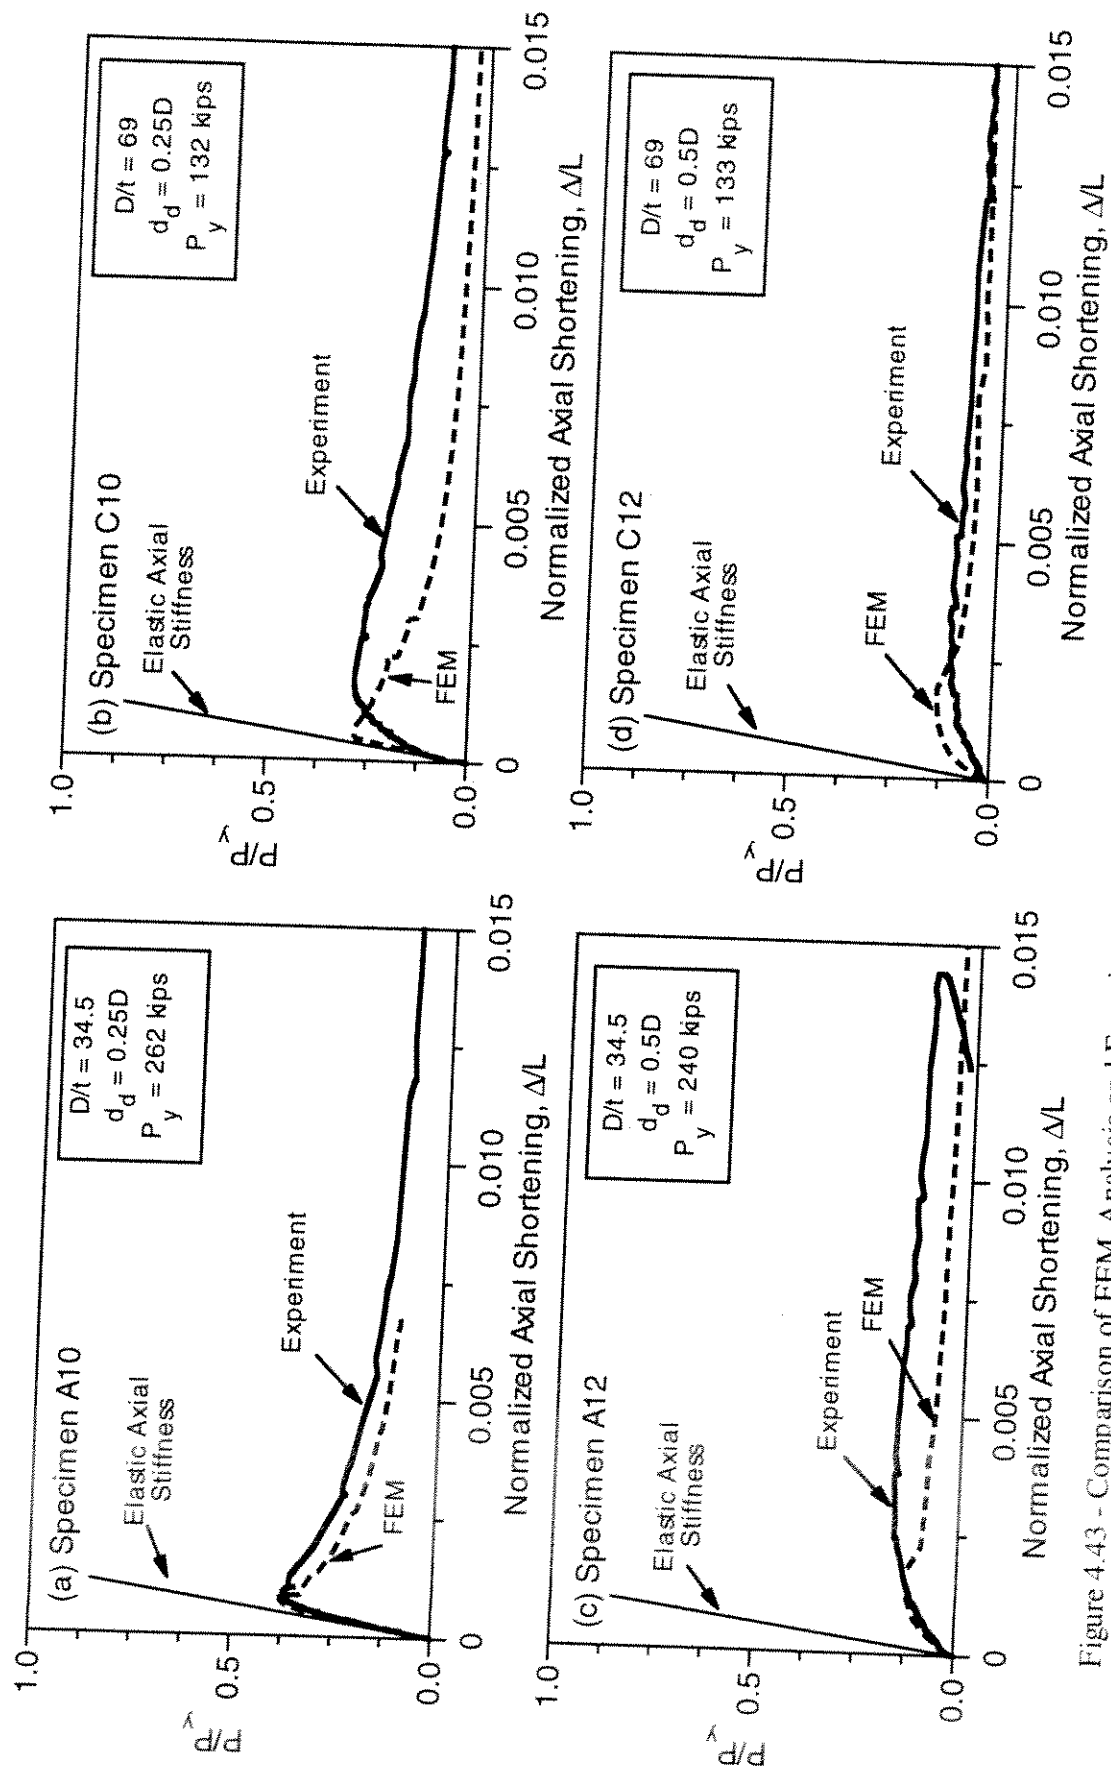
Figure 4.43 - Comparison of FEM Analysis and Experimental Results for the Axial Load-Shortening Response of Non-repaired Specimens

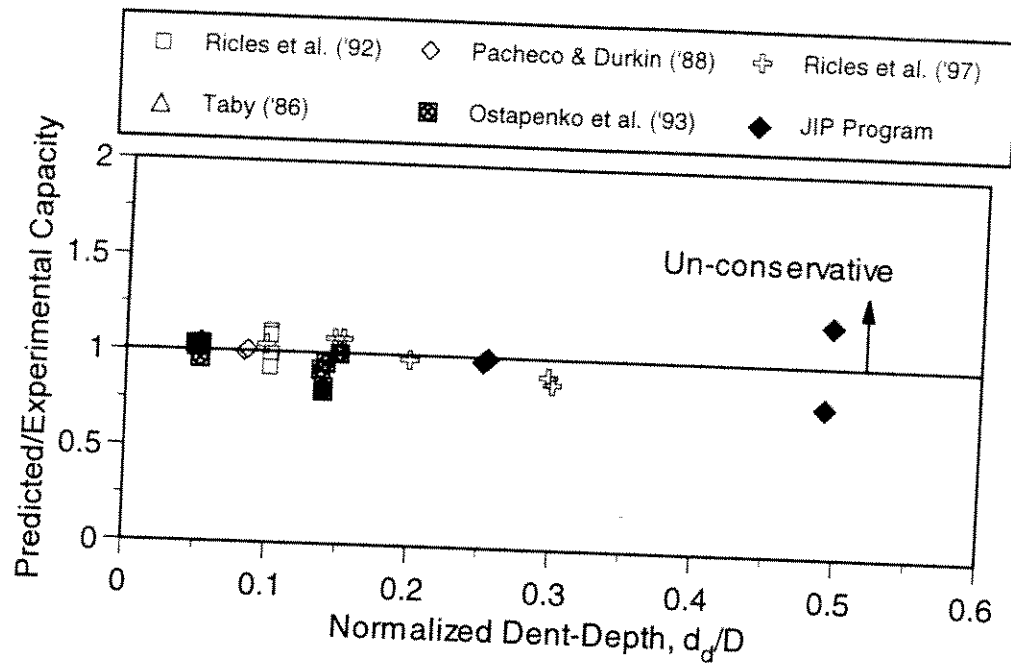
Figure 4.45 - Sensitivity of FEM Analysis to Depth of Applied Dent-Damage for Specimens with Simply-Supported Boundary Conditions

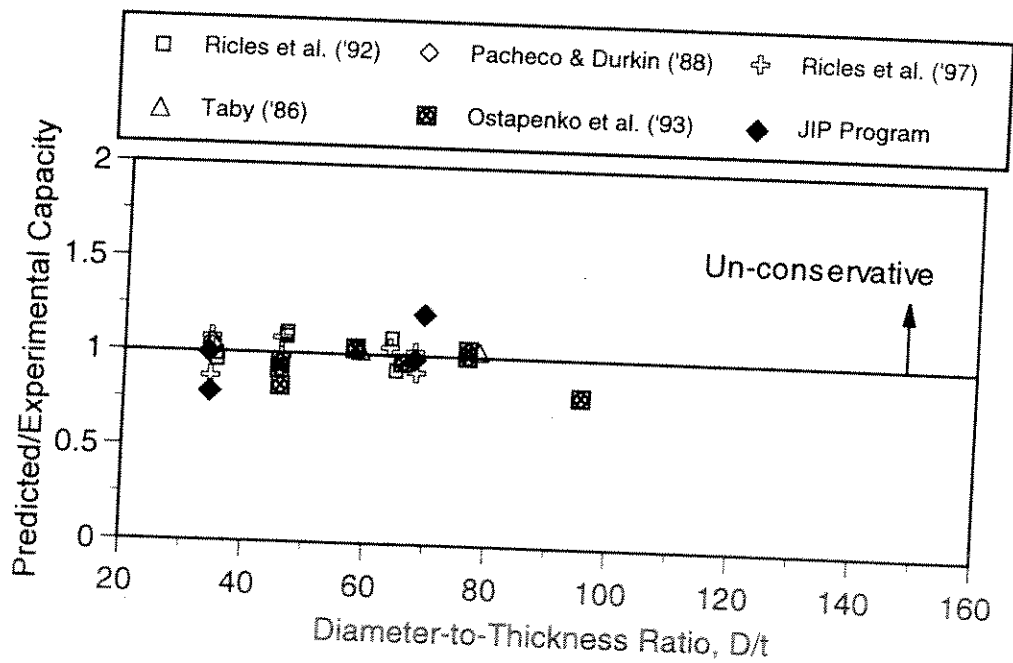
Figure 4.46 - Sensitivity of FEM Analysis to Diameter-to-Thickness Ratio for Specimens with Simply-Supported Boundary Conditions

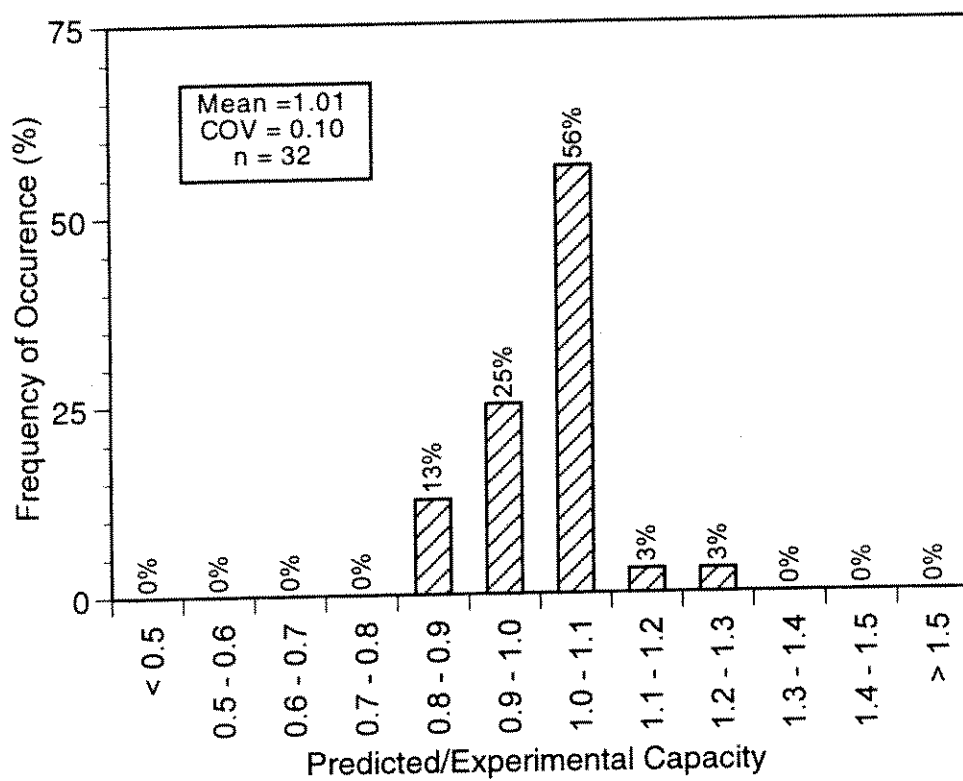
Figure 4.47 - Histogram of Predicted-to-Measured Capacity Ratio for FEM Analysis (Includes Current and Previous Experimental Data)

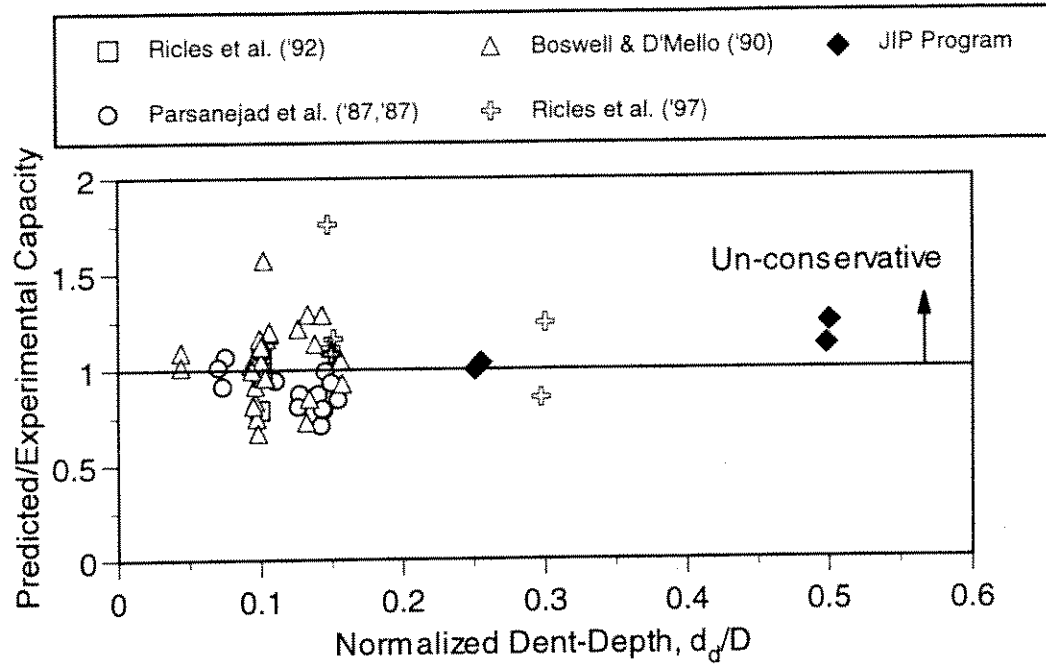
Figure 4.49 - Sensitivity of Parsanejad's Equation to Depth of Applied Dent-Damage for Internal Grout Repaired Specimens

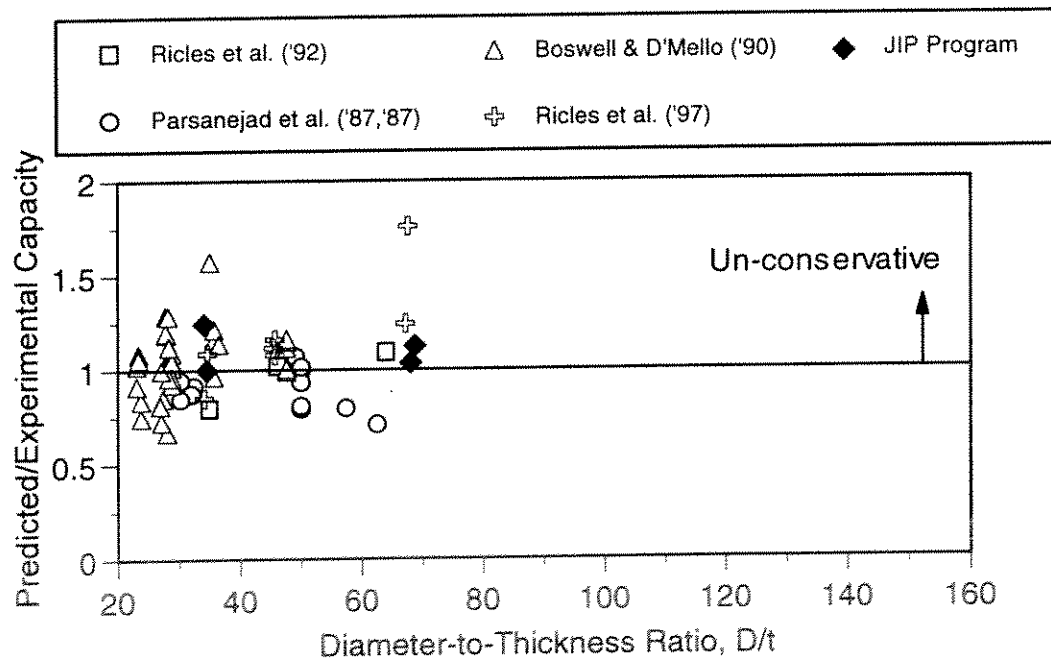
Figure 4.50 - Sensitivity of Parsanejad's Equation to Diameter-to-Thickness Ratio for Internal Grout Repaired Specimens

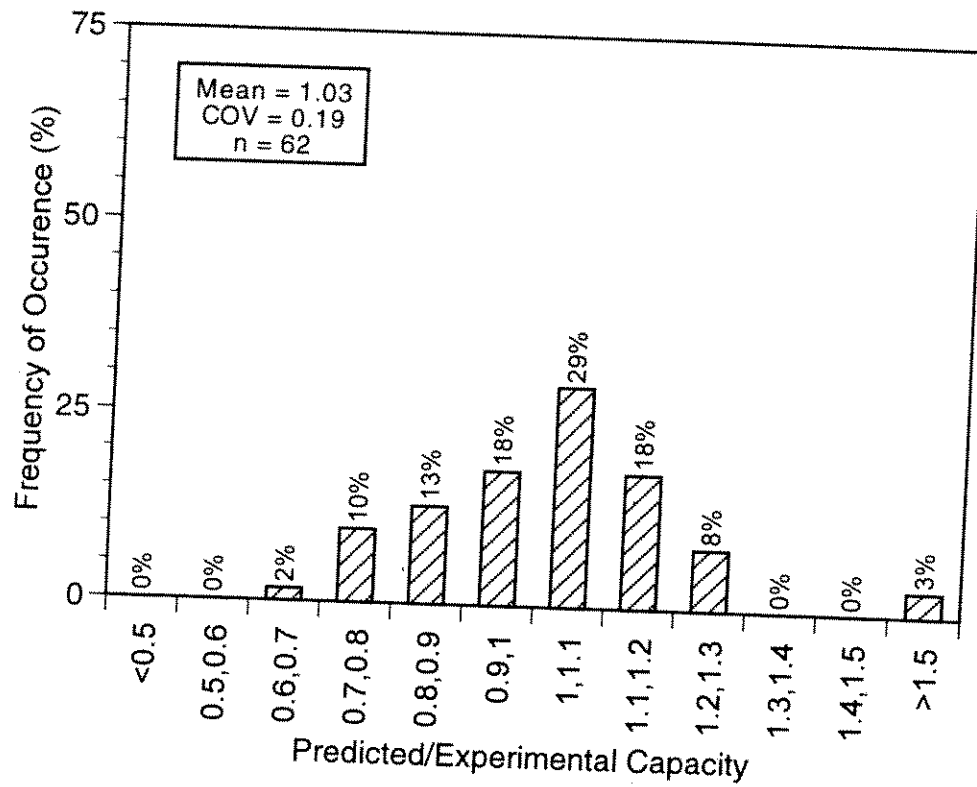
Figure 4.51 - Histogram of Predicted-to-Measured Capacity Ratio for Parsanejad's Equation (Includes Current and Previous Experimental Data)

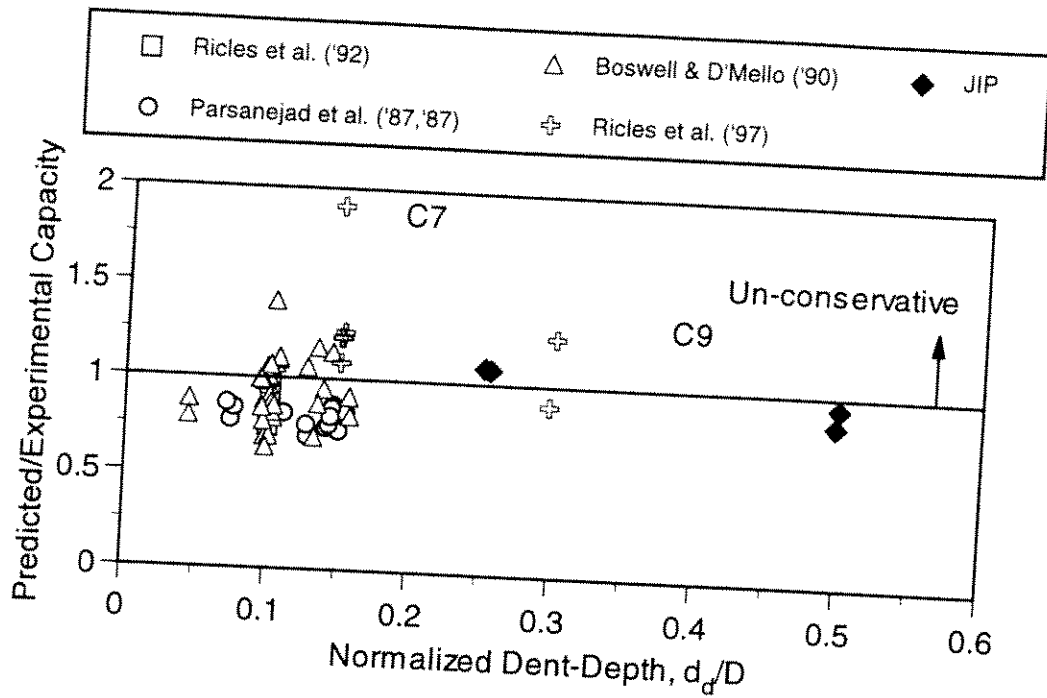
Figure 4.53 - Sensitivity of Loh's Modified AISC-LRFD Equation to Depth of Applied Dent-Damage for Internal Grout Repaired Specimens

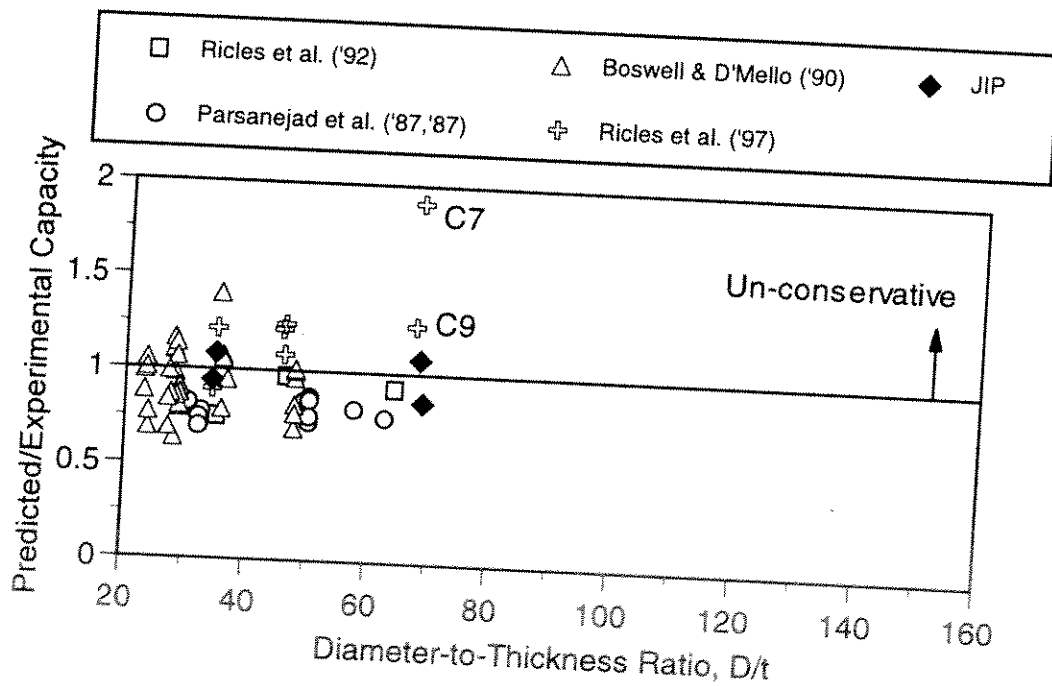
Figure 4.54 - Sensitivity of Loh's Modified AISC-LRFD Equation to Diameter-to-Thickness Ratio for Internal Grout Repaired Specimens
